Fitzroy Water
Quality Program

Protecting the Great Barrier Reef by reducing soil loss in the Fitzroy Region.

2020 - 2024

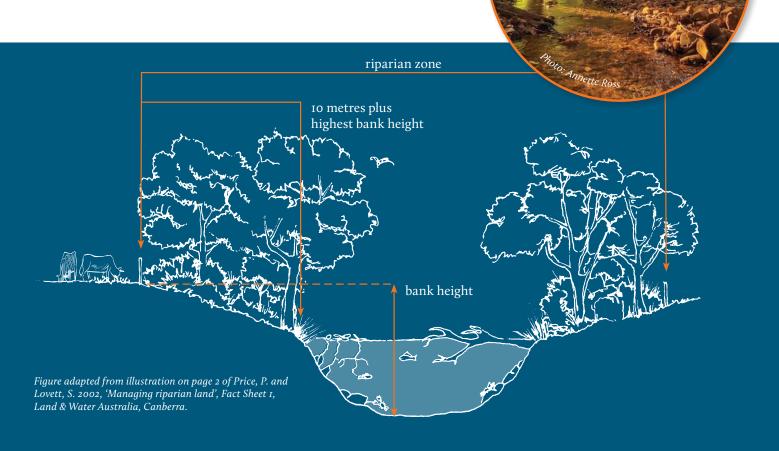
Riparian zone fences should be a minimum of 10 metres from the top of the stream bank, plus the height of the highest point of the bank.

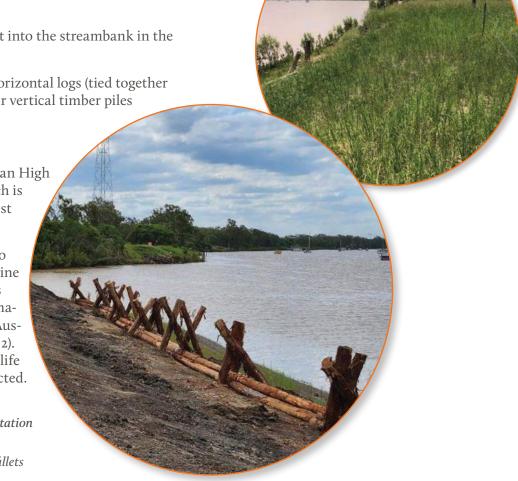
From top: Streambank following revegetation (April 2024)

Bank battering and installation of log fillets in late 2022

Log Fillets are horizontal logs built into the streambank in the intertidal zone.

Each Log Fillet consists of three horizontal logs (tied together and placed on the ground) and four vertical timber piles (two vertical, two angled).

The Log Fillets are installed at Mean High Water Springs (MHWS) level, which is the long-term average of the highest high tide level.
